Molonglo Catchment Health indicator Program Report

July to December, 2010.

Executive Summary

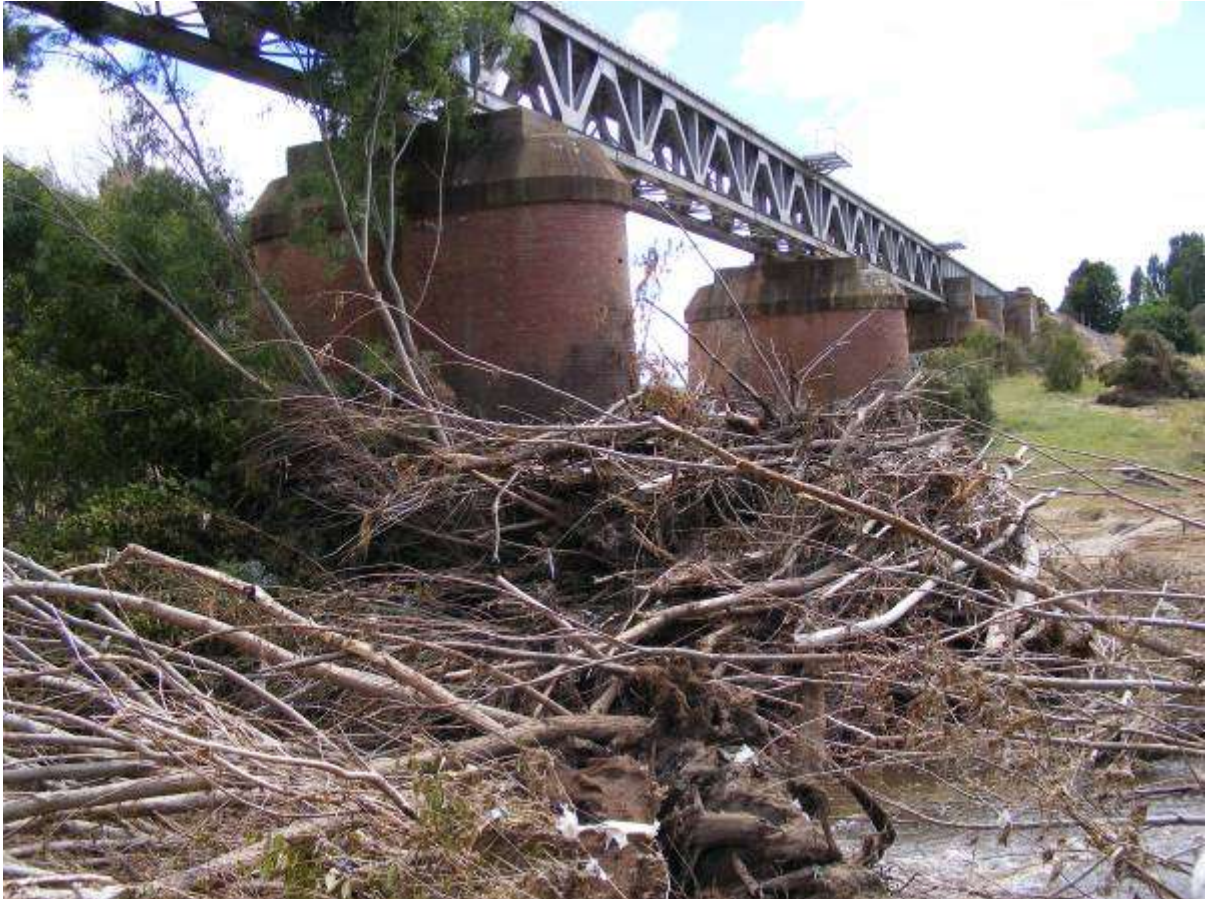
Viaduct, Queanbeyan River, a few days after the flood, December 2010 (Photo: John Bruggeman).

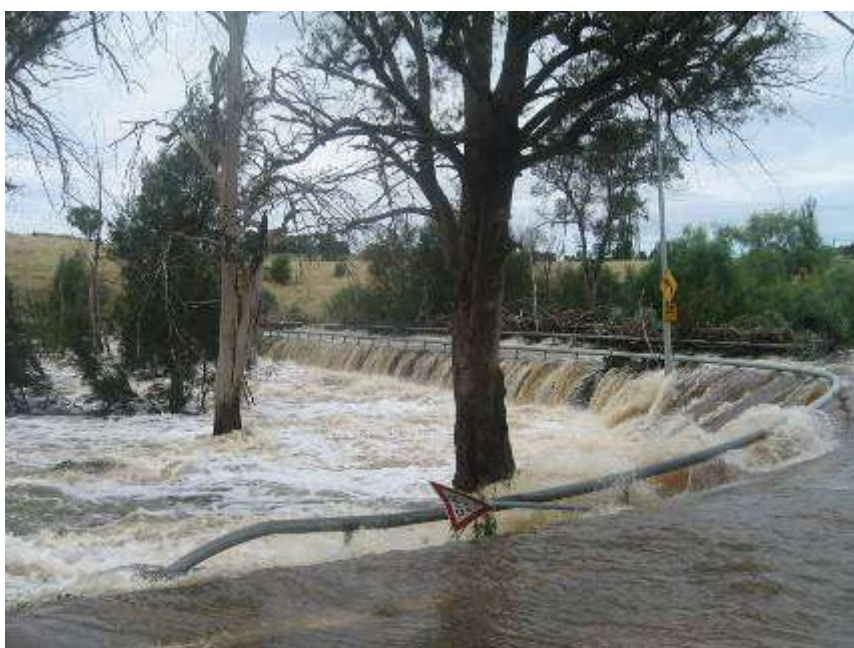
Coppins Crossing, lower Molonglo River, 3 December 2010. (DECCEW)

Although there are only three sample sets from the one site the data indicate a subcatchment under pressure. The sampling site is at the low level causeway at Coppins Crossing and so downstream of the whole catchment except one or two minor creek-lines below William Hovel Drive. The poor dissolved oxygen readings, together with the elevated nitrogen levels, indicate that discharges downstream of the metropolitan area contain materials stirred up by the unusually frequent rain events in this half of 2010. A CHiP score of 3.0 indicates a waterway in moderate condition, which is a reasonable view of a river in almost continuous elevated flow for six months.

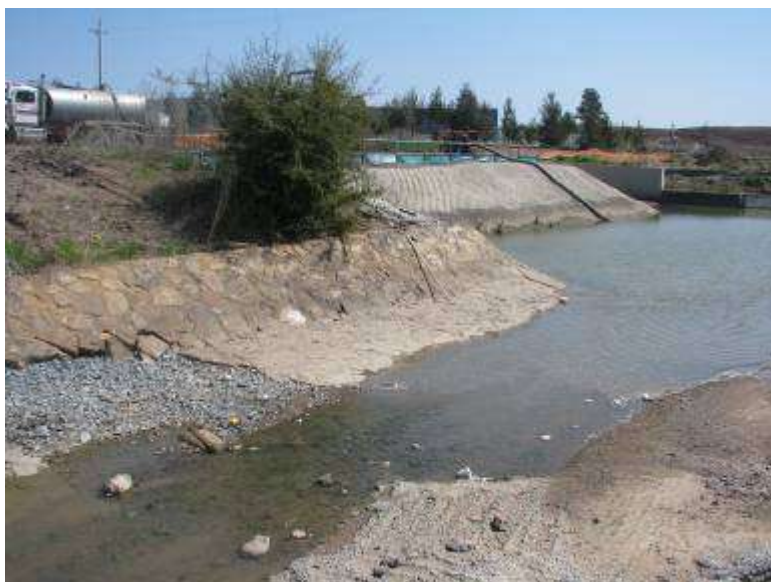
Weston Creek below Cotter Rd, as a construction site.

With no results from Weston Creek in this period (the site is a construction site and difficult to access) the sampling point on Yarralumla Ck at Cotter Rd, just below Curtin, is the only information we have for this sub-catchment. All the parameters are elevated throughout the sample period, indicating repeated disturbance of the catchment. The persistently high nitrate levels indicate that the local horse paddocks act as a sink for such nutrients in dry times with release in times of high soil moisture. A

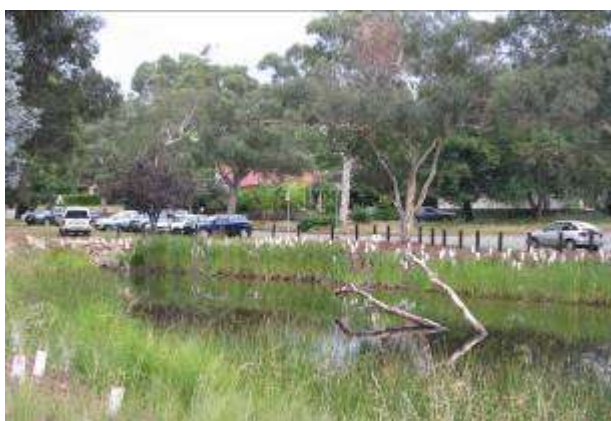
Banksia Street Wetland, now 1 year old

A recent addition to Sullivans Creek has been an inline wetland upstream from Flemington Road near the racecourse. The four off-line wetlands in North Watson and Justice Robert Hope Reserve are now being monitored, as are both of the wetlands in the O’Connor hill drain-line at Banksia Street and David Street. Except in the wetland,

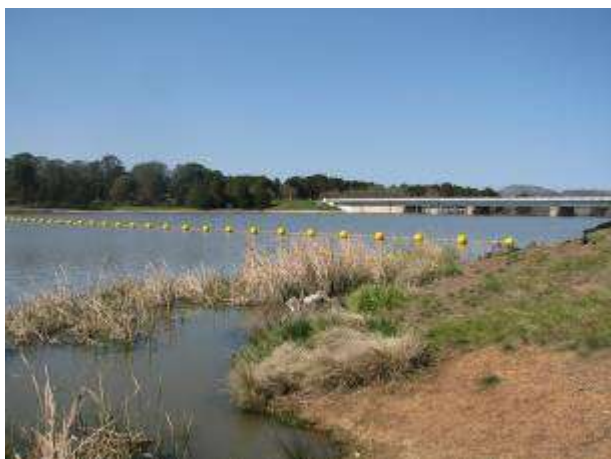
Lake Burley Griffin, just before the Scrivener Dam wall.

The waters of the Lake Burley Griffin subcatchment in the second half of 2010 give an indicator score of 2.65, indicating good water health, tending a little to moderate. With higher than usual rainfall and runoff over the period, this is a good result. Turbidity rarely dropped to 20 NTU, although the Lake, being soft bottomed, is unlikely to become clearer than that even in years of little rainfall. The volunteers sample close to shore, and the Dissolved Oxygen reports remained satisfactory in the sample period, even in Norgrove Wetland, where good primary productivity by both algae and aquatic plants was to be expected, and may have shown either too elevated or depleted levels. The west and central basins of the east lake had consistently elevated pH values, a condition often

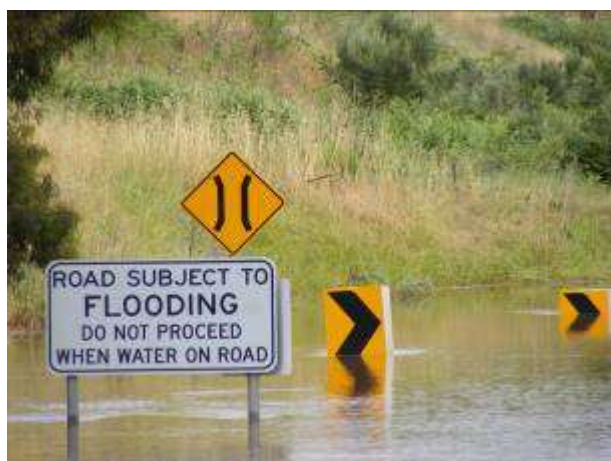
Oaks Estate Rd Crossing, at the height of the December flood. (John Bruggeman)

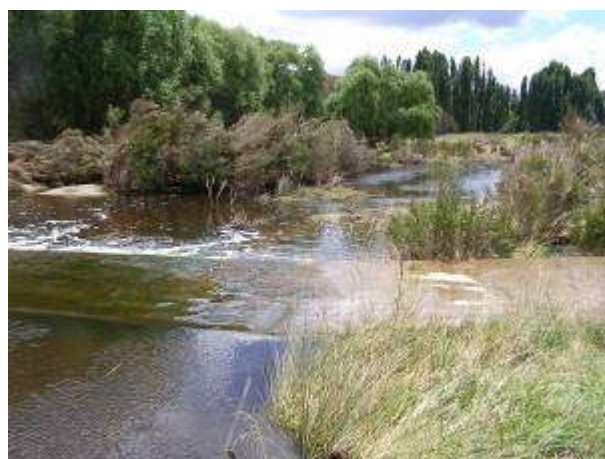
Queanbeyan R., Boolboolma Crossing in December. (John Moore)

The whole sub-catchment rating (**2.06** or **Good** Catchment Water Health) is very close to the long term expectation. The regular high flows and, later in the year, floods have supported low values for Electrical Conductivity and pH readings close to neutral, except in the high country. The variations in phosphate levels are a good reflection of run-off in the area. The scores indicate that if land disturbance can be kept to a minimum and reliable flows are maintained, then this subcatchment will have little difficulty showing Excellent Catchment Health once again.
